**FLEET MOORING
UNDERWATER INSPECTION REPORT
LA MADDALENA, ITALY**

FPO 1-81 (24)
DECEMBER 81

OCEAN ENGINEERING
AND CONSTRUCTION PROJECT OFFICE
CHESAPEAKE DIVISION
NAVAL FACILITIES ENGINEERING COMMAND
WASHINGTON, DC 20374

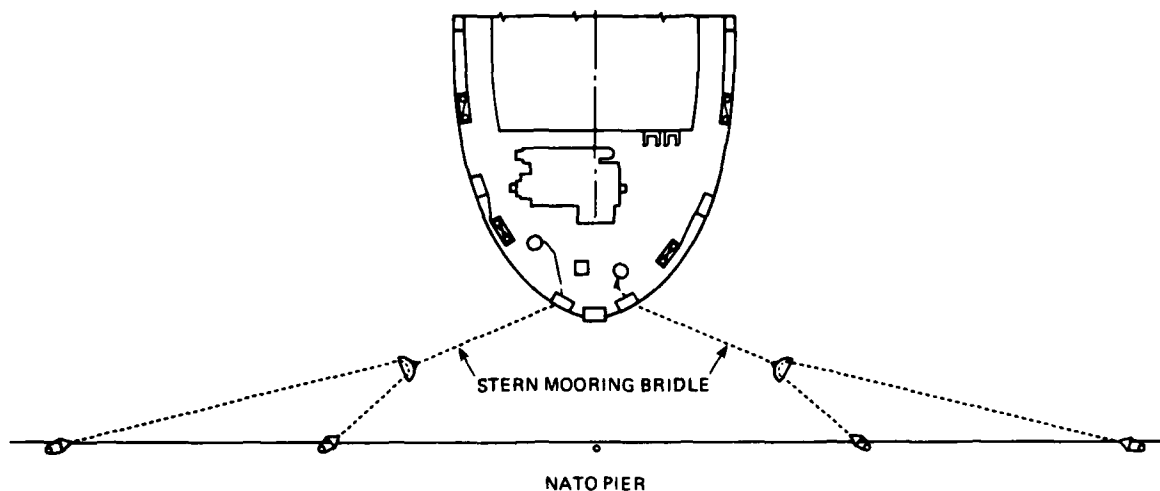
Figure A-1-1. La Maddalena Mooring, Stern Legs

1.2 Findings. All of the chain was coal tar epoxy or black paint coated and, with all of the sample wire diameter measurements taken showing greater than 90 percent of the original size, it appeared to be in good condition. Those links of chain which passed through the starboard equalizer had lost about 50% of their coating due to rubbing, and some light rust had formed. The equalizers were also coated, but about 30% of their surface areas had some light rust. The swivel above the equalizer, in each of the mooring bridles, contained a notch on each side of the lower wire, as shown in Figure A-1-2. These notches, however, did not appear to be caused by wear, and the swivels may have been cast this way during fabrication.

1.3 Conclusions/Recommendations. When the submarine Tender departs the mooring, the stern leg assemblies are presently dropped into the water and left hanging from the bollards. Thus, the majority of these assemblies are underwater about 20 percent of the time. It is recommended that a portable crane be utilized to lift the leg assemblies to the pier for storage when the ship deploys.
